**NASA Technical Memorandum 82956**

# **Ferrographic and Spectrometer Oil Analysis From a Failed Gas Turbine Engine**

**William R. Jones, Jr.**  
*Lewis Research Center  
Cleveland, Ohio*

**Prepared for the  
International Conference on Advances in Ferrography  
sponsored by the University College of Swansea  
Swansea, United Kingdom, September 22-24, 1982**

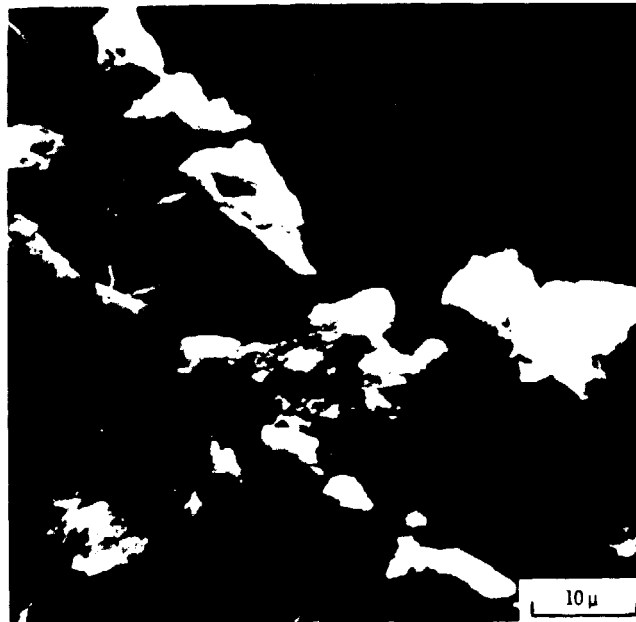
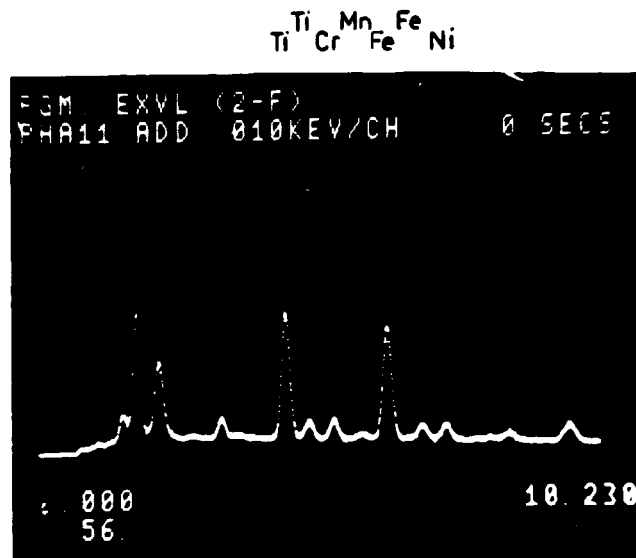
Figure 1. - Wear debris from oil sample 9/10/76 (before failure).

Ferrographic analysis (before failure). - Oil samples were also analyzed using the Ferrograph and selected areas of Ferrograms were further analyzed in a scanning electron microscope. An electron micrograph of wear debris from the engine oil sample (September 10, 1976) appears in figure 1(a). A typical particle (A) is analyzed by X-ray dispersive energy analysis (EDX) in figure 1(b). Particle A is predominantly Ti and Fe with lesser amounts of Cr, Mn, and Ni. It should be noted that in any small particle analysis using EDX, there may be surrounding particle interference. This means that contributions to some of the EDX peaks may be from surrounding or underlying particles or substrate since the analyzing depth or volume may, in some cases, be greater than the size of the analyzed particle.

(a) Electron micrograph of wear debris.

(b) EDX analysis of particle A.

The particle morphology of figure 1(a) is essentially that of normal rubbing wear particles (a benign form of wear) (refs. 7 and 8). However, there were spherical particles evident in the prefailure sample and an electron micrograph appears in figure 2(a). EDX analysis of the spheres appears in figure 2(b) and the background analysis of the glass Ferrogram appears in figure 2(c). The presence of Au is due to the evaporated Au film to prevent charging in the SEM. These spheres are essentially pure Fe. No other elements (besides the background elements) are detected by EDX. These large 10- to 15- $\mu$ m-diameter spheres are probably contaminants in the oil. Spherical particles have been related to bearing fatigue (refs. 7-10), but spheres from fatigue are usually much smaller (1 to 5  $\mu$ m in diameter) and have analyses similar to the bearing steel. Large spheres have been associated with cavitation erosion (ref. 8) and grinding (ref. 11).

particles were formed. In addition, the particle analysis from figure 6(b) is very similar to the analysis of the particle in figure 1(b) which was from a sample taken prior to the failure. There definitely were Ti-containing particles in the engine lubricant prior to the engine failure.

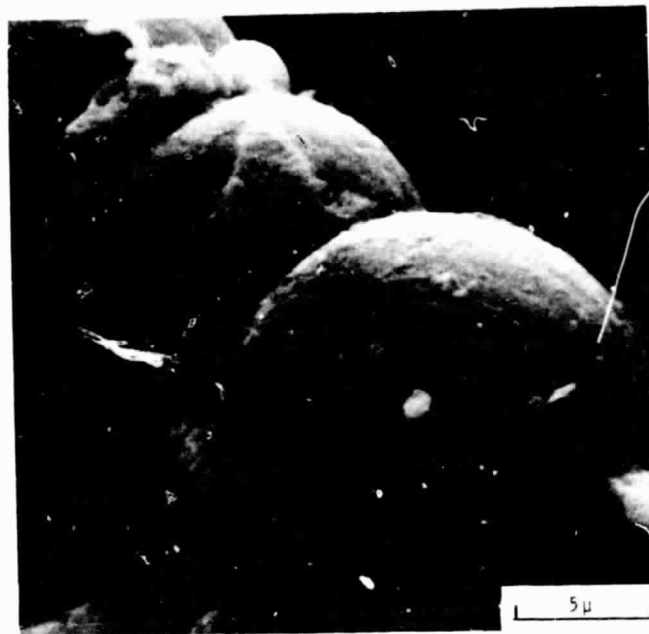
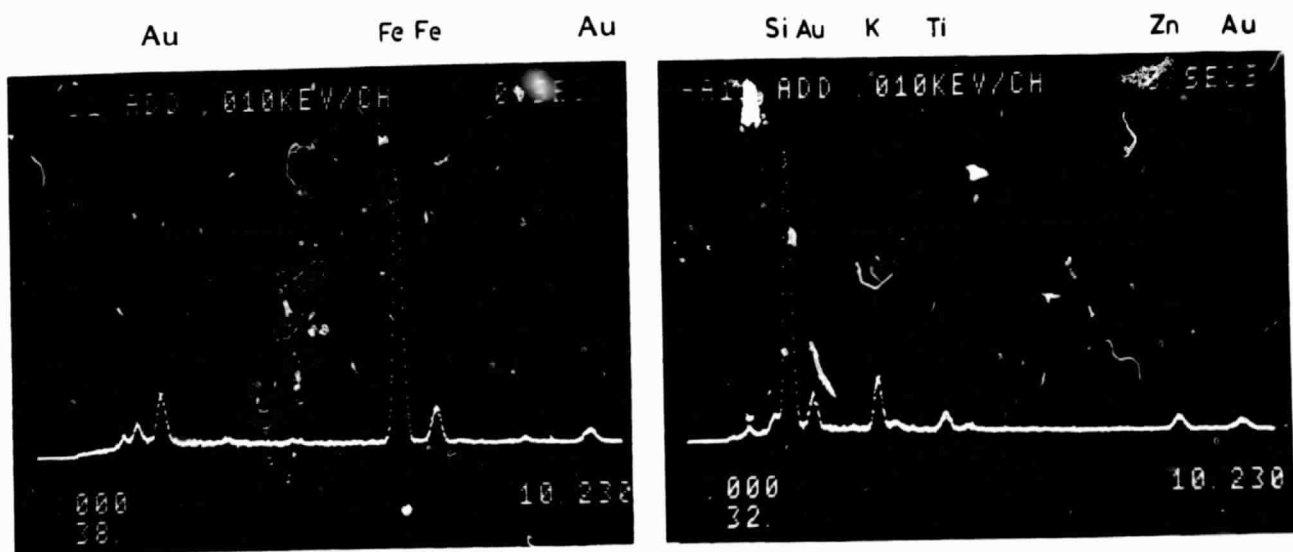
Figure 2. - Spherical particles from oil sample 9/10/76 (before failure).

(a) Electron micrograph of spherical particles.

(b) Energy dispersive X-ray analysis (EDX) of spheres.

(c) Background EDX of ferrogram.

Essentially the same area on the Ferrogram that appears in figure 2(a) is mapped for the distribution of Fe, Ti, Cu, and Si in figures 3(b) to (e). As can be seen, the majority of the particles contain Fe, while one particle contains Ti. Most of the Si and Cu is from the background.

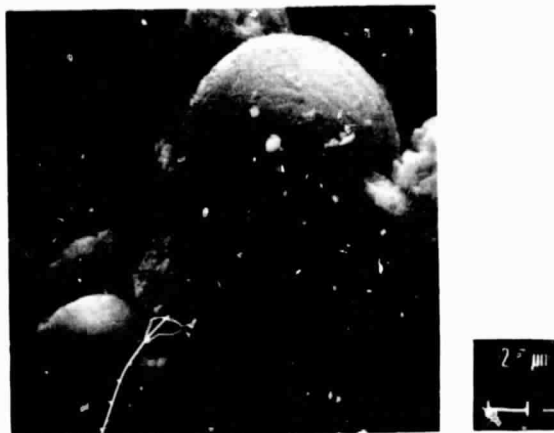
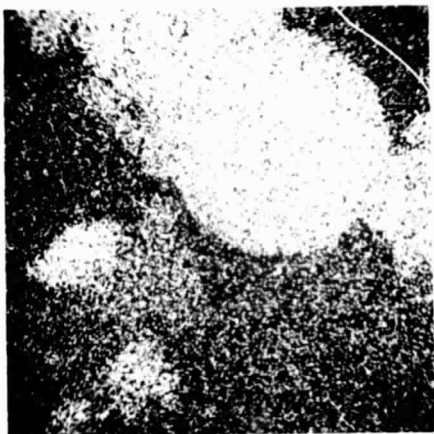
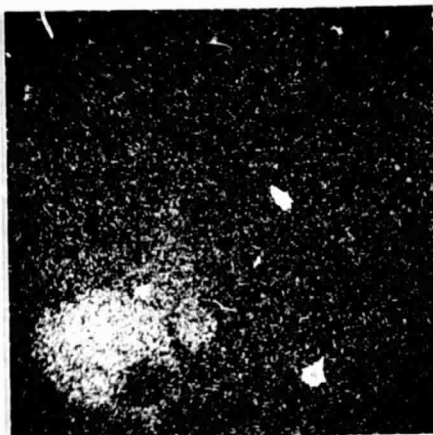
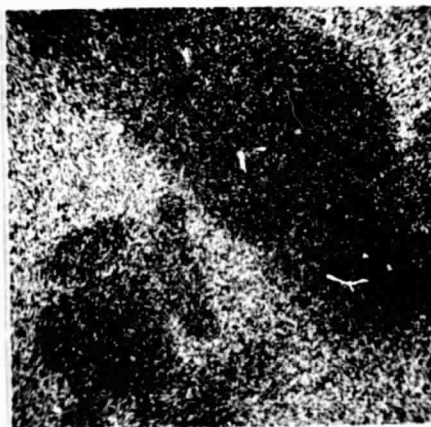
Figure 3. - Spherical particles and debris from oil sample 9/10/76 (before failure) and accompanying elemental X-ray maps.

(a) Electron micrograph of spherical particles and debris

(b) X-ray distribution of Fe.

(c) X-ray distribution of Ti.

(d) X-ray distribution of Cu.

(e) X-ray distribution of Si.

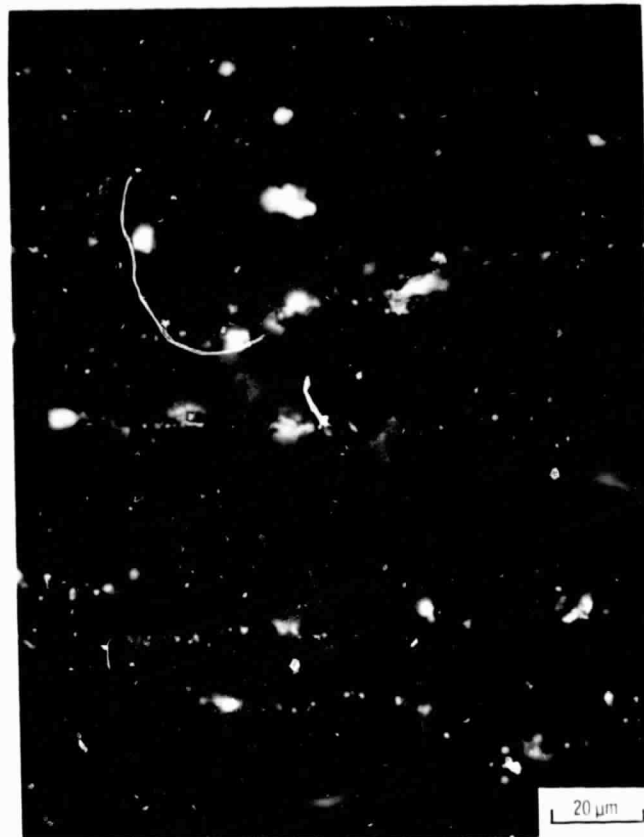
Ferrographic analysis (after failure). - Figure 4 shows the type of particles present in the oil taken from the oil filter after the failure. As can be seen, the majority are spherical or spheroidal in nature. In reflected white light, the spherical particles have a variety of colors from white, to straw-colored, to deep blue. There is also evidence of tear-shaped or globular par-

ticles. These shapes, combined with the variety of colors, are indicative of a high-temperature melting and resolidification process. These particles are shown at higher magnification in figure 5.

Figure 4. - Optical micrograph of spherical particles and debris from oil in oil filter (after failure).

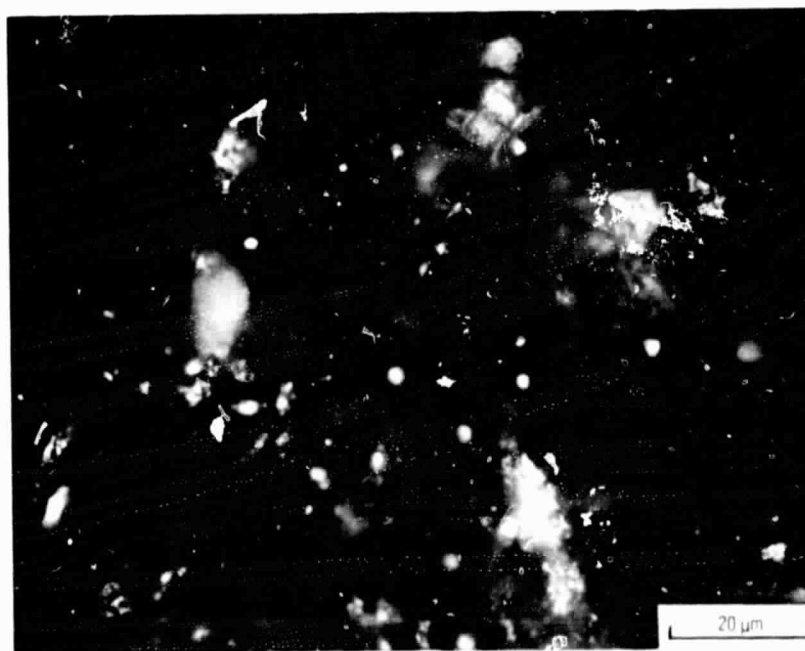
Figure 5. - Debris from oil sample from oil filter (after failure).

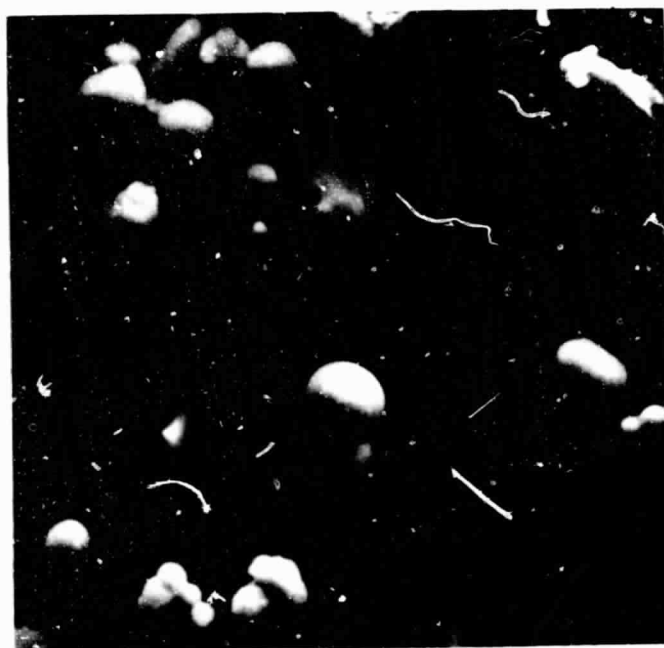
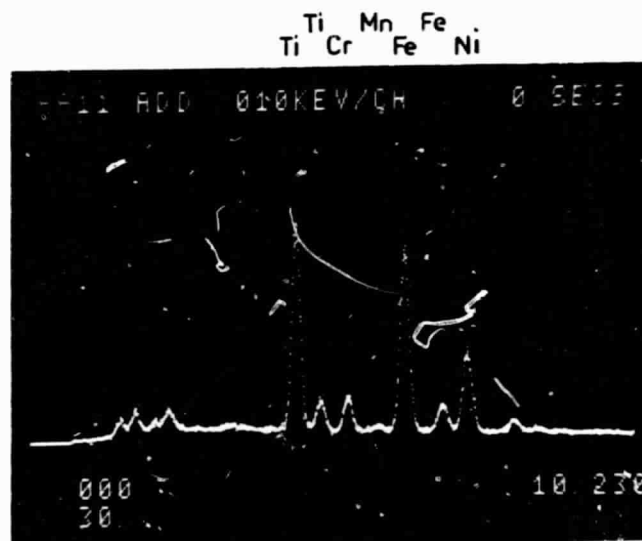
Figure 6. - Debris from oil sample 9/14/78 (after failure).

Electron micrographs of debris from the engine oil sample (September 14, 1976) show similar particle types. These are shown in figure 6(a) with an accompanying EDX analysis in figure 6(b). The particles are predominantly Ti and Fe with lesser amounts of Cr and Ni.

(a) Electron micrograph of debris.

(b) Typical EDX analysis of particles.

It was hoped that analysis of this debris might indicate the location of the high speed rub. The nominal composition of the shroud material (Metco 301) is 69 percent Ni, 14 percent Cr, 8 percent Fe, 5.5 percent BN and 3.5 percent Al. The labyrinth seal material is AMS 430 which has a composition of 83 percent Fe, 17 percent Cr and 1 percent Mn. Examining many particles by EDX after failure (such as in fig. 7) was inconclusive. No analysis exactly matched the above compositions. This is not surprising considering the manner in which the

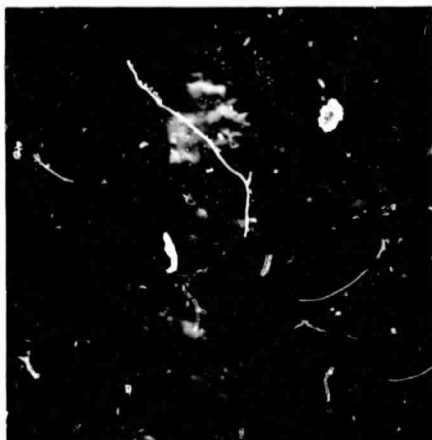
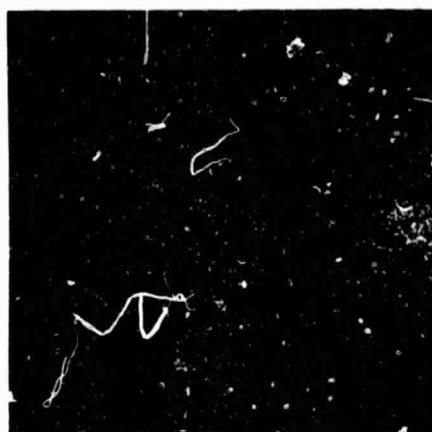
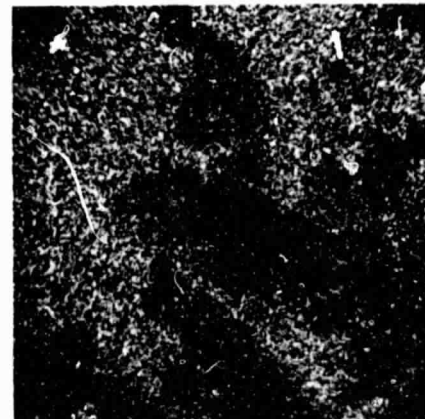
Figure 7. - Debris from oil sample 9/14/76 (after failure) and accompanying elemental X-ray maps.

Another micrograph of debris from engine sample (September 14, 1976) is shown in figure 7(a). X-ray distribution maps for Ti, Fe, Ni, Cr and Si appear in figures 7(b) through (f), respectively. In support of the previous figure, the debris consists of Ti and Fe with small amounts of Ni and Cr. The Si is essentially from the Ferrogram slide.

(a) Electron micrograph of debris.

(b) X-ray distribution of Ti.

(c) X-ray distribution of Fe.

(d) X-ray distribution of Ni.

(e) X-ray distribution of Cr.

(f) X-ray distribution of Si.

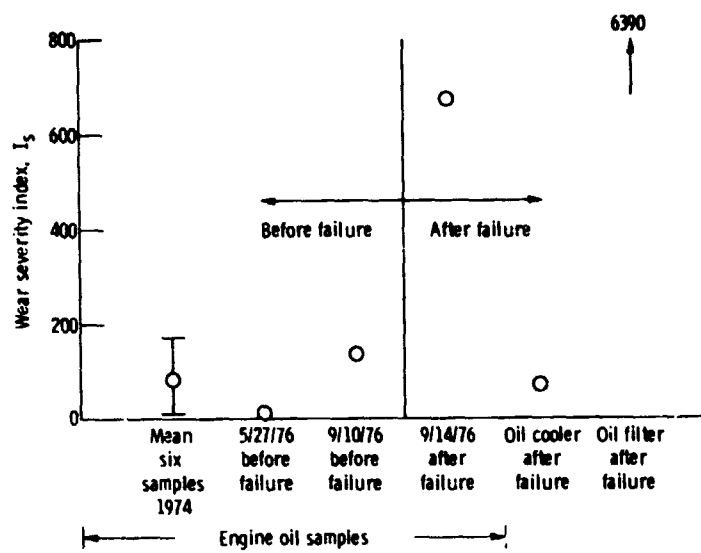
$I_S$  values for all of the oil samples, including the mean and standard deviation of six engine samples from 1974, are shown in figure 8. The  $I_S$  increased from about 10 to 140 from the May 27, 1976, sample to the September 10, 1976 sample. Although this is a large increase prior to failure, it is not significant when compared to the range of  $I_S$  values obtained from this engine in the past (i.e., 1974 samples). After failure,  $I_S$  values increase dramatically. This, of course, is expected. An especially large value was obtained from the oil filter sample.

Figure 8. - Wear severity index ( $I_s$ ) for various oil samples.

Wear severity index. - A parameter, the wear severity index, has been advocated by Bowen and Westcott (ref. 7). This parameter is calculated from optical density measurements made at the entry position of the Ferrogram ( $A_L$ ) and at the 50-mm position ( $A_S$ ). These are the areas covered by the large and small particles. Their sum ( $A_L + A_S$ ) yields the general level of wear, while their difference ( $A_L - A_S$ ) gives an indication of abnormality. These two quantities multiplied together  $(A_L + A_S)(A_L - A_S)$  yield the wear severity index  $A_L^2 - A_S^2$ , usually abbreviated  $I_S$ .
